Technical Memorandum 79022

DEVELOPMENT OF SPRAYED CERAMIC SEAL SYSTEM FOR TURBINE GAS PATH SEALING

TECHNICAL PAPER to be presented at the
Winter Annual Meeting
sponsored by the American Society of Mechanical
Engineers
San Francisco, California, December 10-15, 1978

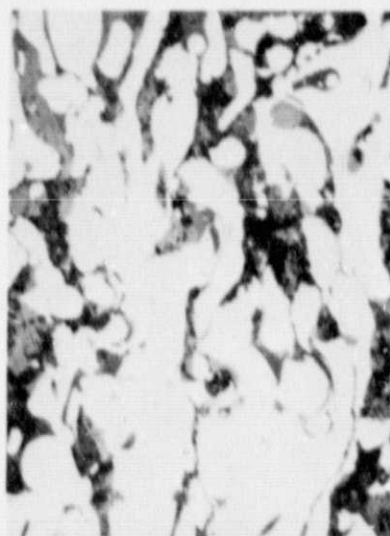
Figure 3. - Microstructure of layers comprising the plasma sprayed seal system; X500, 37 percent reduction.

ZrO₂

85/15 ZrO₂/CoCrAlY

70/30 ZrO₂/CoCrAlY

40/60 ZrO₂/CoCrAlY

The functions of the intermediate cermet layers are to mitigate thermal stresses due to the engine operating cycle by: (1) grading the thermal expansion and elastic properties of the seal system in a stepwise manner between those of the YSZ and the MAR M-509 substrate; and (2) providing a somewhat compliant or resilient buffer between the YSZ and the MAR M-509. Measured physical and mechanical properties for each layer composition (except the NiCrAl bond layer) are summarized in table I. Representative micrographs showing porosity distribution and distribution of constituents in each of these layers are shown in figure 3.

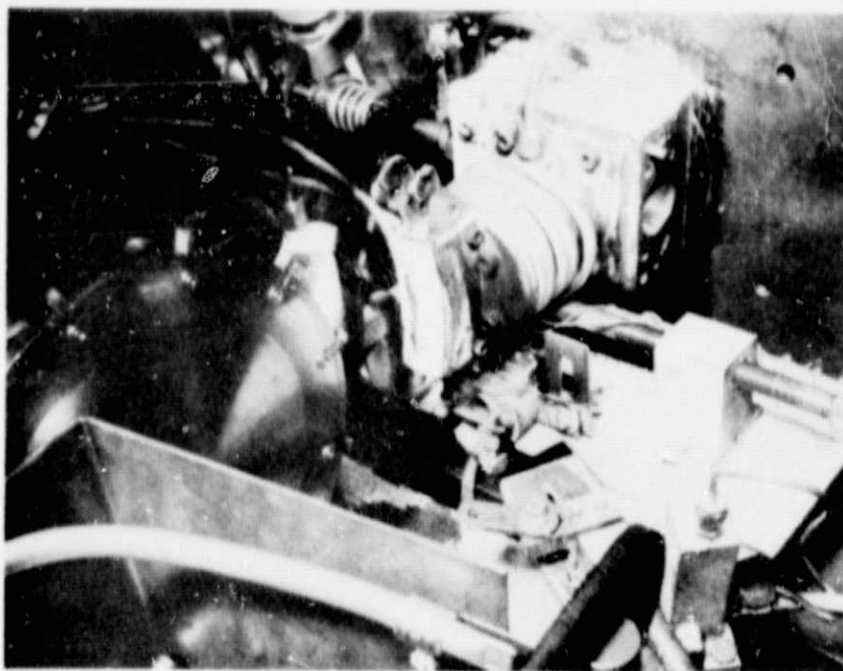
Figure 10. - High temperature abrasability test rig. Note: Near side heating torch not shown.

SEAL TEMP. - 1589 K (2400° F)
 NO. BLADES - 12
 BLADE MAT'L - PWA 1455
 BLADE TIP TKNS. - 0.3175 cm (0.125 in.)

Abradability tests were performed on the test rig shown in figure 10. Twelve simulated turbine blade-tips made of B-1900 alloy (Ni-8 percent Cr-10 percent Co-1 percent Ti-6 percent Al-0.11 percent C) were mounted in the periphery of a disk. An air turbine was used to drive the disk so that the blade tip speed was 310 m/sec (1000 ft/sec). The seal segment specimen was mounted in a fixture at the end of a horizontal post attached to a movable carriage assembly. The carriage assembly injects the specimen radially into the rotor assembly at the required incursion rate. The seal specimen was heated from both sides of the rotor by oxygen-acetylene torches directed at the seal surface. Heating torches were also mounted off the carriage assembly. Firing rate and distance between the torches and seal specimen was varied to control the seal surface temperature, nominally 1309° C (2400° F) for all tests.

Seal surface temperature and blade tip temperature were monitored by optical pyrometers. Carriage travel was monitored by a linear differential transformer. A load cell in the carriage feed system permitted determination of the average normal force between the seal specimen and blade tips. All data were recorded continuously on a strip chart.
